# **A Preliminary Assessment of Fish Lake**

**Michiana Fish Lake Association  
71029 Michigan Boulevard  
White Pigeon, Michigan 49099**

**International Science & Technology, Inc.  
P.O. Box 349  
10501 Hague Road  
Fishers, Indiana 46038**

**August 1990**

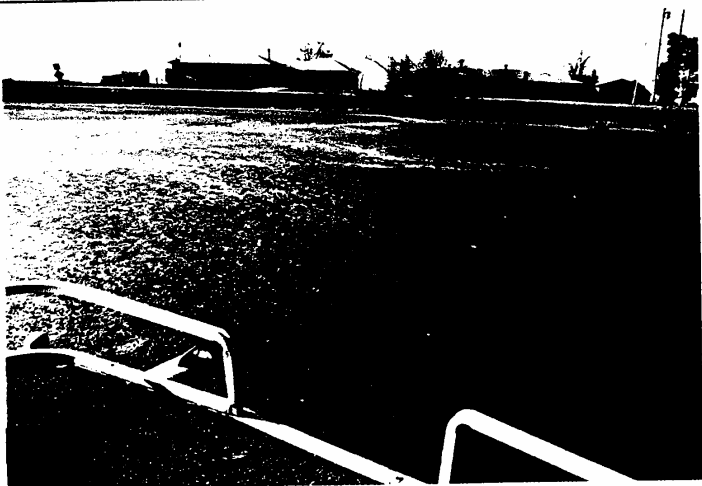
Figure 1. Filamentous algae on Fish Lake during spring 1990. (Photo courtesy of B. Giles, Michiana Fish Lake Assoc.)

comm., Michiana Fish Lake Association, 1990). Macrophyte growth within the photic zone of the lake has been heavy, with mats of filamentous algae interspersed throughout the macrophyte beds. In previous years, macrophyte control has been accomplished through the use of herbicides and weed harvesting (P. Wysong, pers. comm., Michiana Fish Lake Association, 1990). During the late spring of 1990, heavy mats of filamentous algae covered the majority of the surface area of the lake (Figure 1). Macrophyte growth during the summer of 1990 has not been as great as in previous years.
